**Fourth Five-Year Review Report for
Silver Bow Creek/Butte Area Superfund Site
EPA ID MTD980502777**

**Butte
Silver Bow and Deer Lodge Counties, Montana**

January 2016

Prepared by:
United States Environmental Protection Agency
Region 8
Denver, Colorado

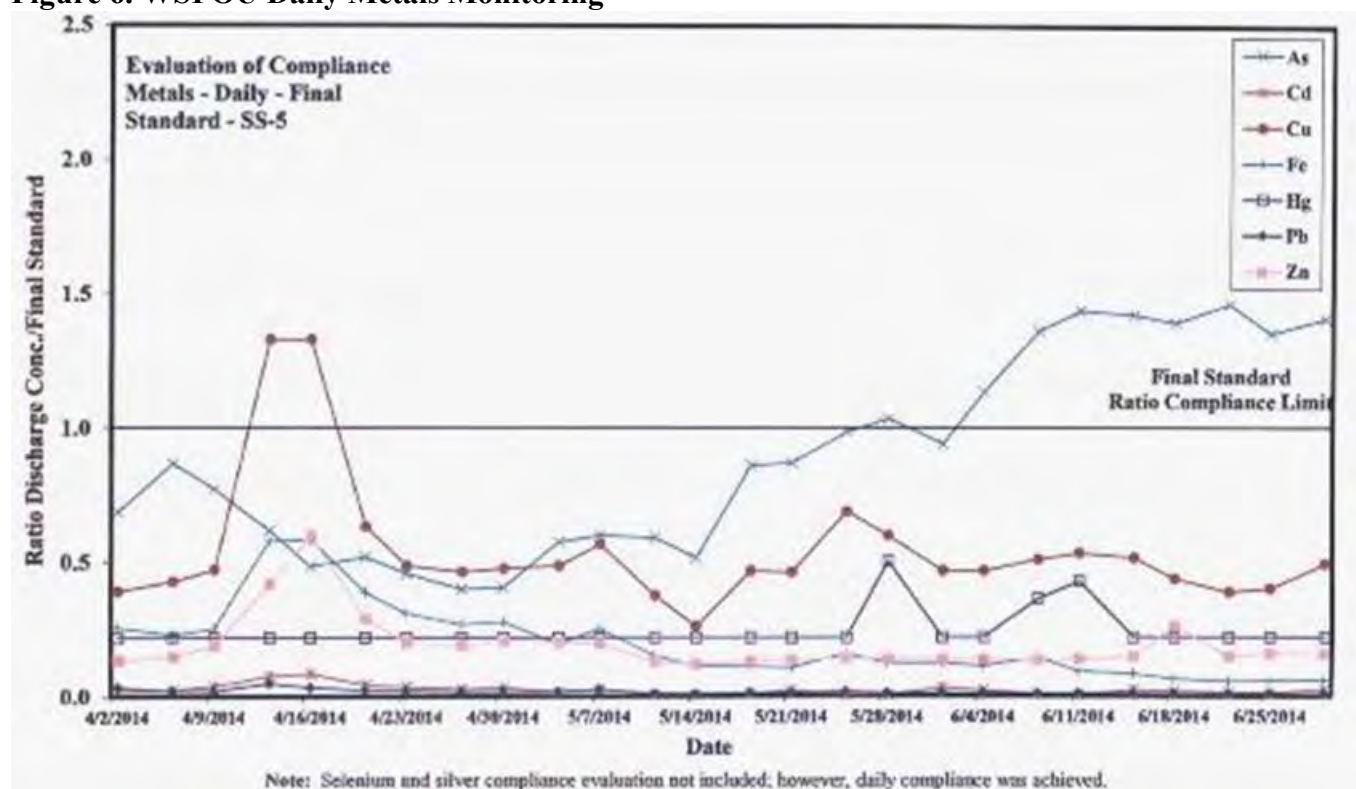
Figure 6. WSPOU Daily Metals Monitoring

- The highest measured arsenic value was 0.0292 mg/L, which occurred in June 2014. This value exceeded the discharge standard of 0.0200 mg/L by 0.0092 mg/L.
- The highest measured copper value was 0.0423 mg/L, which occurred in April 2014. This value exceeded the final discharge standard of 0.0318 mg/L by 0.0105 mg/L.
- The highest measured pH value was 9.84, which occurred in June 2014.

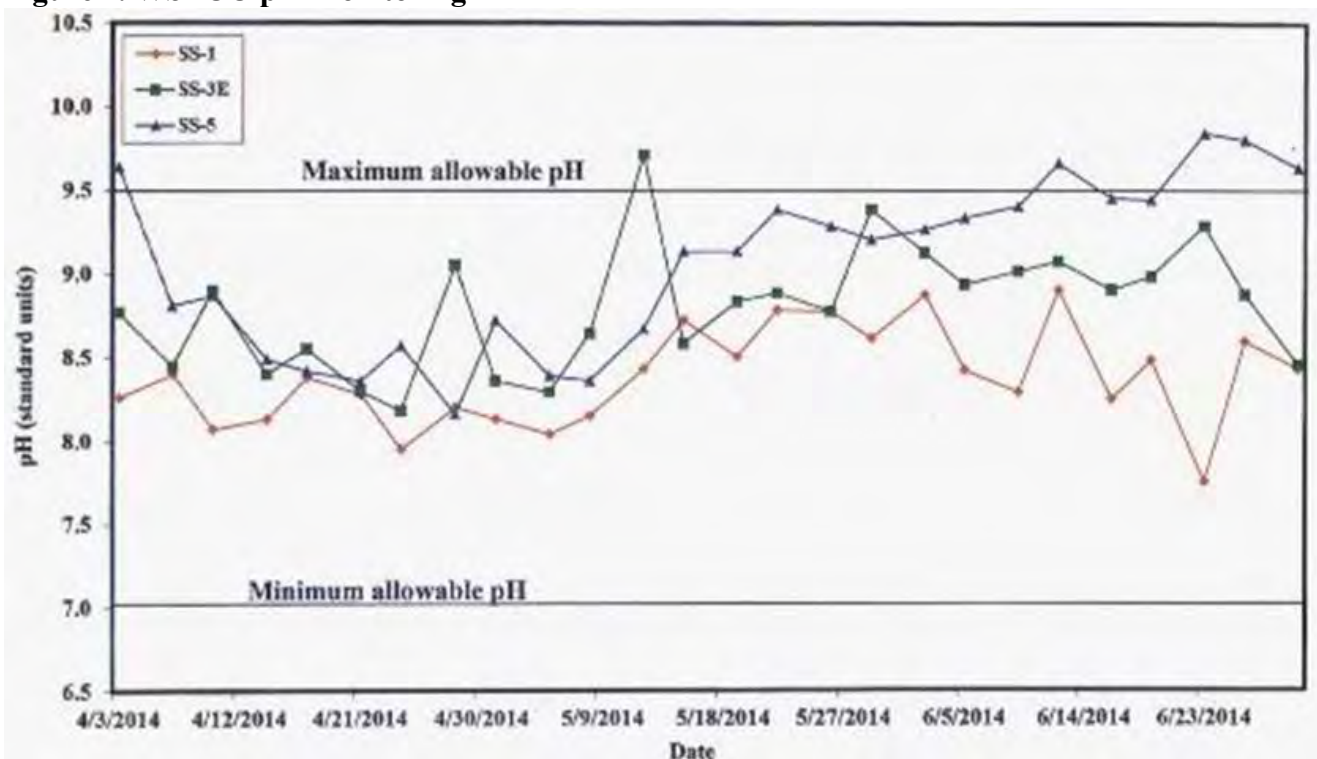
Figure 7. WSPOU pH Monitoring

- The pH at the Pond 2 discharge (SS-5) ranged from 8.2 to 9.8 during the reporting period.
- The pH within the system (SS-3E and SS-5) was maintained above 7.0 during the entire reporting period.

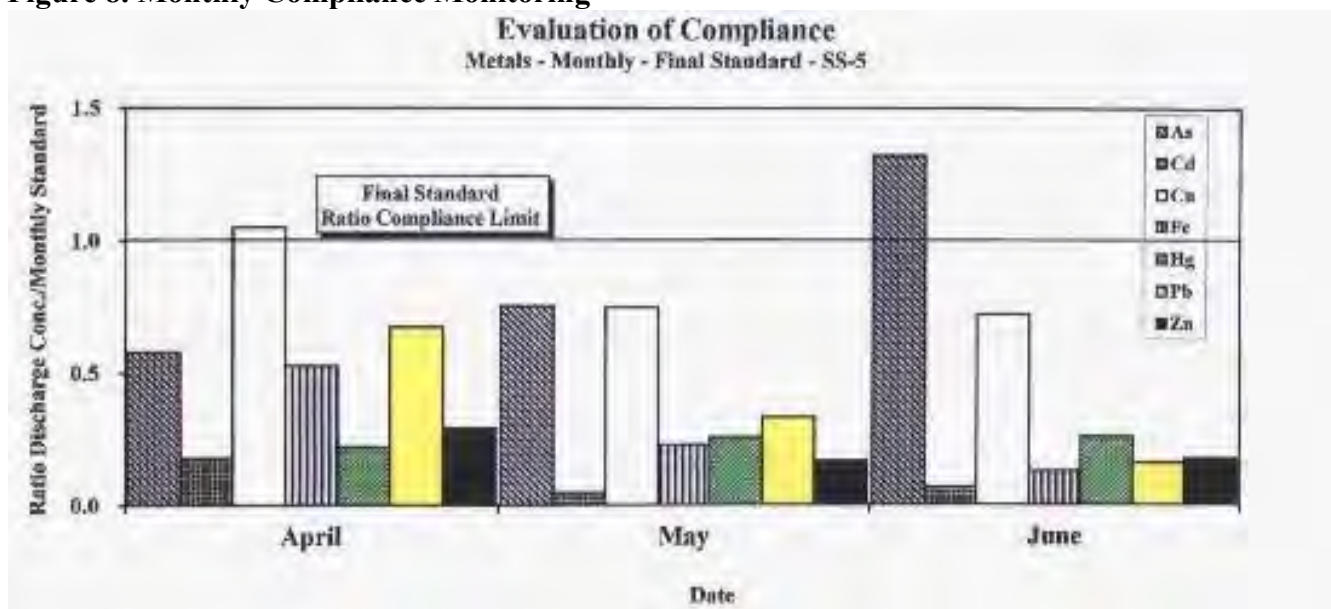
Figure 8. Monthly Compliance Monitoring

The monthly averages for all constituents were in compliance with the Monthly Final Standard for the months of April, May and June, with the exception of copper and arsenic (Figure 8). The following supplemental observations were made:

In general, constituent concentrations decreased through the Warm Springs Ponds system, in the order of inflow (SS-1) > Pond 3 discharge (SS-3E) > Pond 2 discharge (SS-5) for most constituents the majority of the time. Monthly sampling results applicable to the Mill-Willow Bypass are presented in Appendix F.

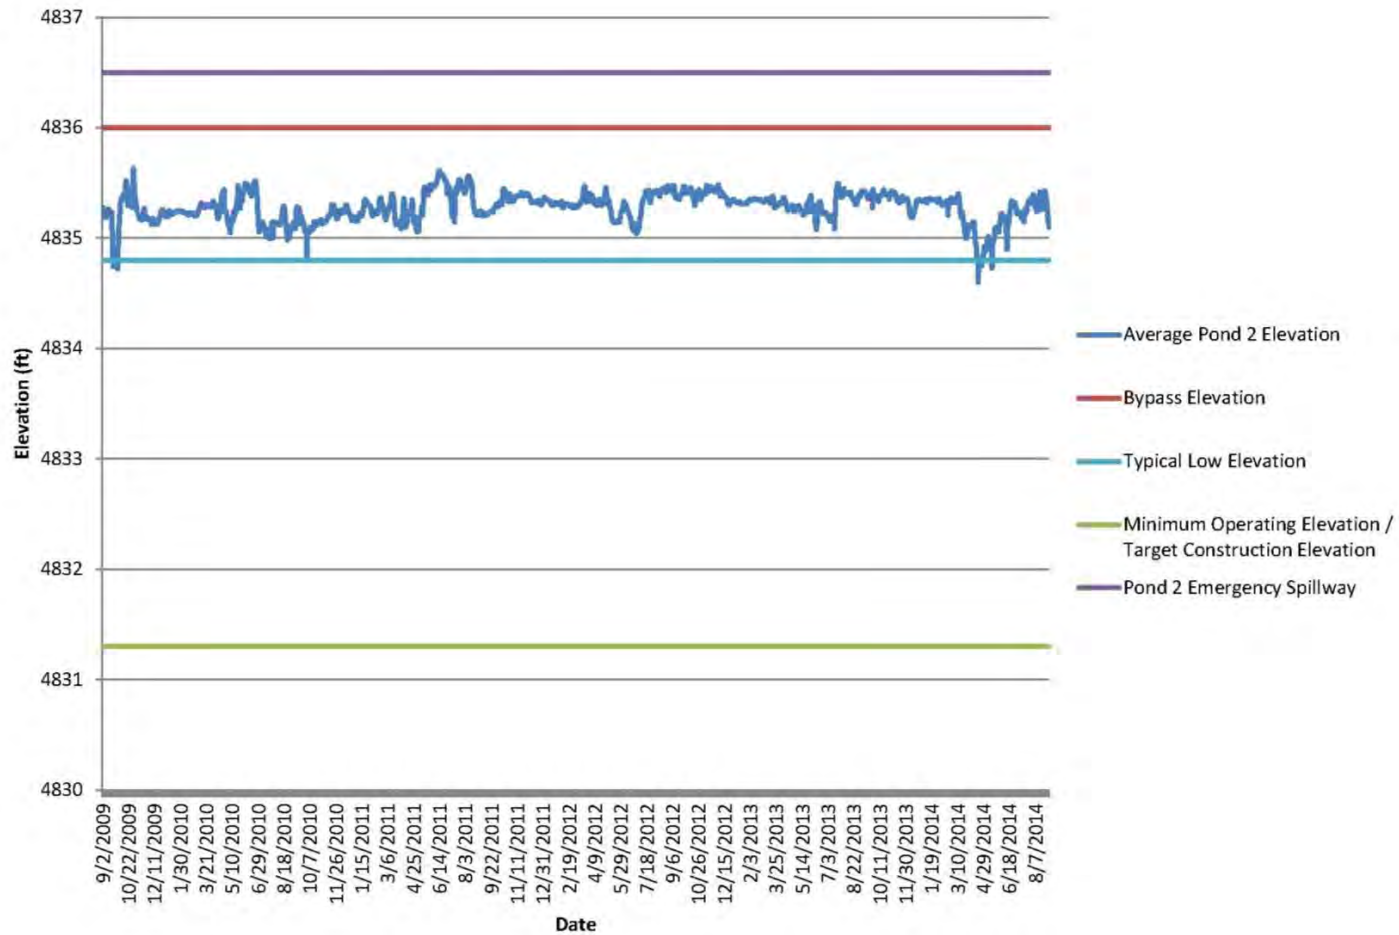
Figure 9. Pond 2 Operating Elevations

Semi-annual groundwater monitoring activities were conducted during the reporting period. Groundwater quality data from these activities are presented in Appendix F. Groundwater measured at the point of compliance does not exceed performance standards and is not used for drinking water. Pond 2 and Pond 3 dewatering elevations are included in Figures 9 and 10.

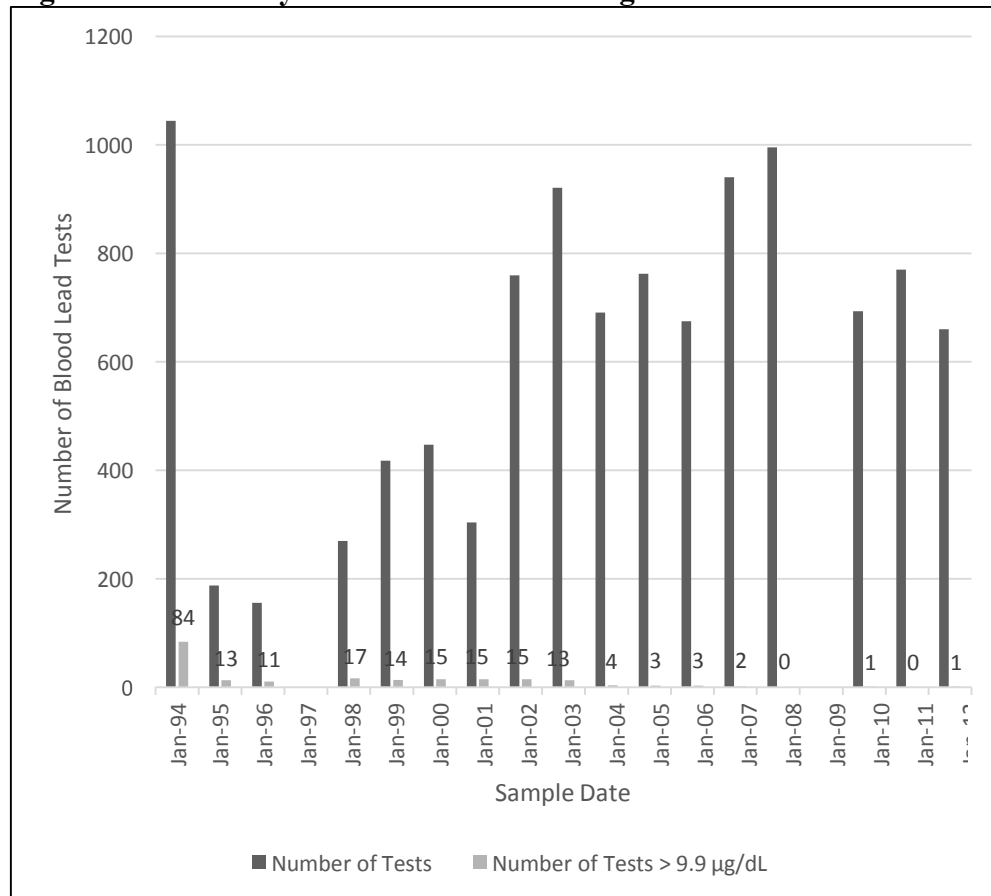
Figure 13: Summary of Blood Tests Resulting in Exceedance of Lead Reference Levels

abatement. The Butte-Silver Bow Health Department concluded that blood lead levels in Butte children have declined dramatically since 2003. Average values for 2010 were less than half of the values for 2003, with geometric means having declined from 3.5 $\mu\text{g}/\text{dL}$ in 2003 to 1.6 $\mu\text{g}/\text{dL}$ in 2010. The geometric means over these time periods are below the new Centers for Disease Control and Prevention reference level of 5.0 $\mu\text{g}/\text{dL}$. The percent of blood lead levels above 10.0 $\mu\text{g}/\text{dL}$ declined by a similar magnitude, while the percent of blood lead levels above 5.0 $\mu\text{g}/\text{dL}$ declined by an even greater margin, decreasing from 33.6 percent in 2003, to 9.5 percent in 2010.

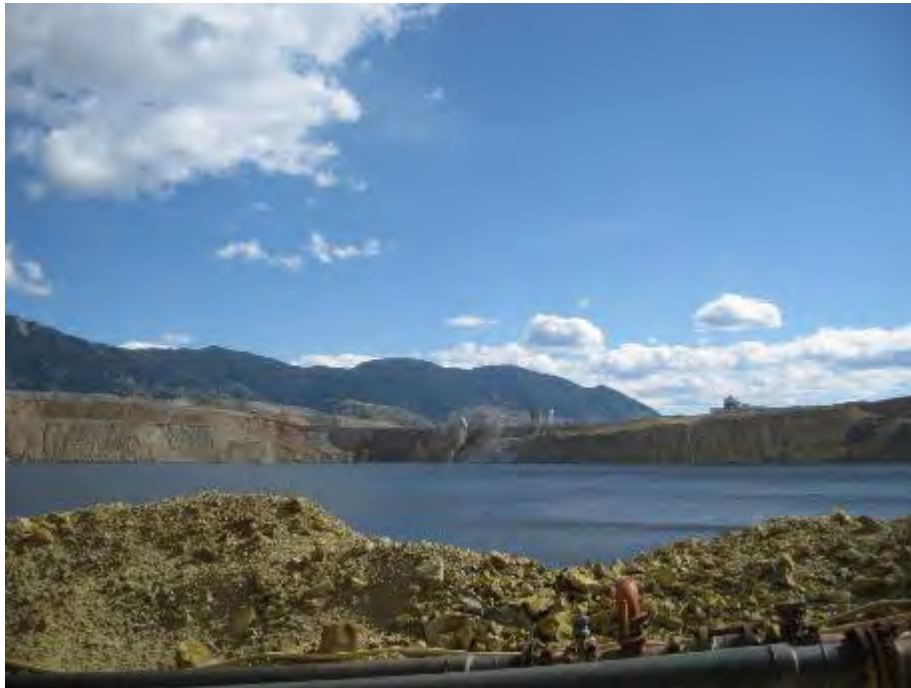
BMFOU: At the water surface of Berkeley Pit – two pumps had gotten disconnected

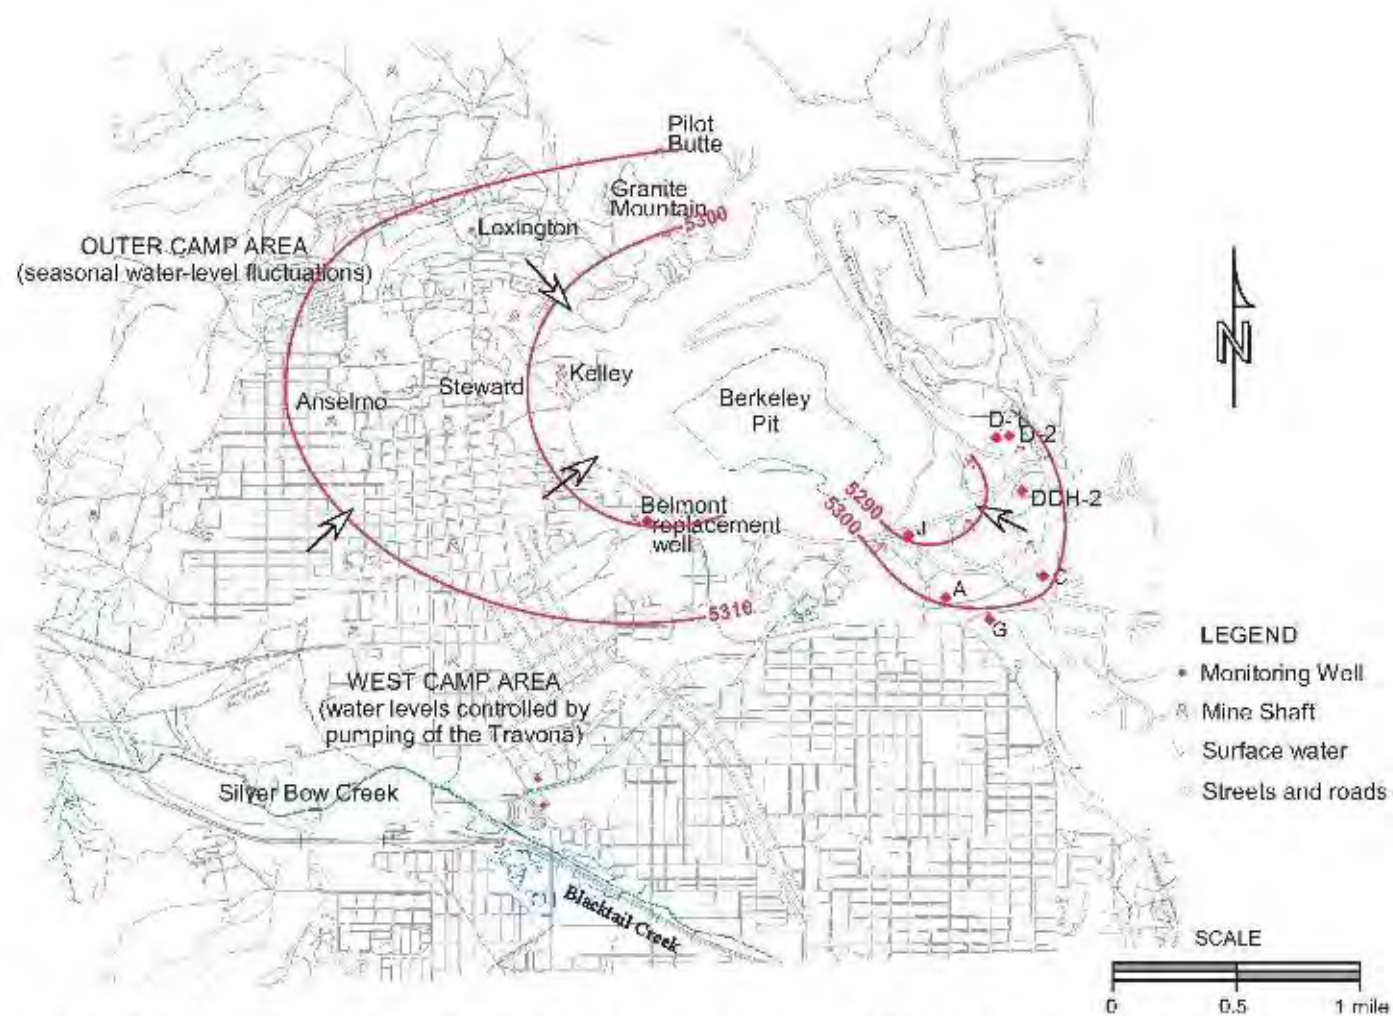
Figure E-2: Potentiometric Map for the East Camp Bedrock Aquifer

Figure 3-3. Potentiometric map for the East Camp bedrock aquifer, December of 2009; arrows indicate direction of ground-water flow (contour interval is 10 feet).

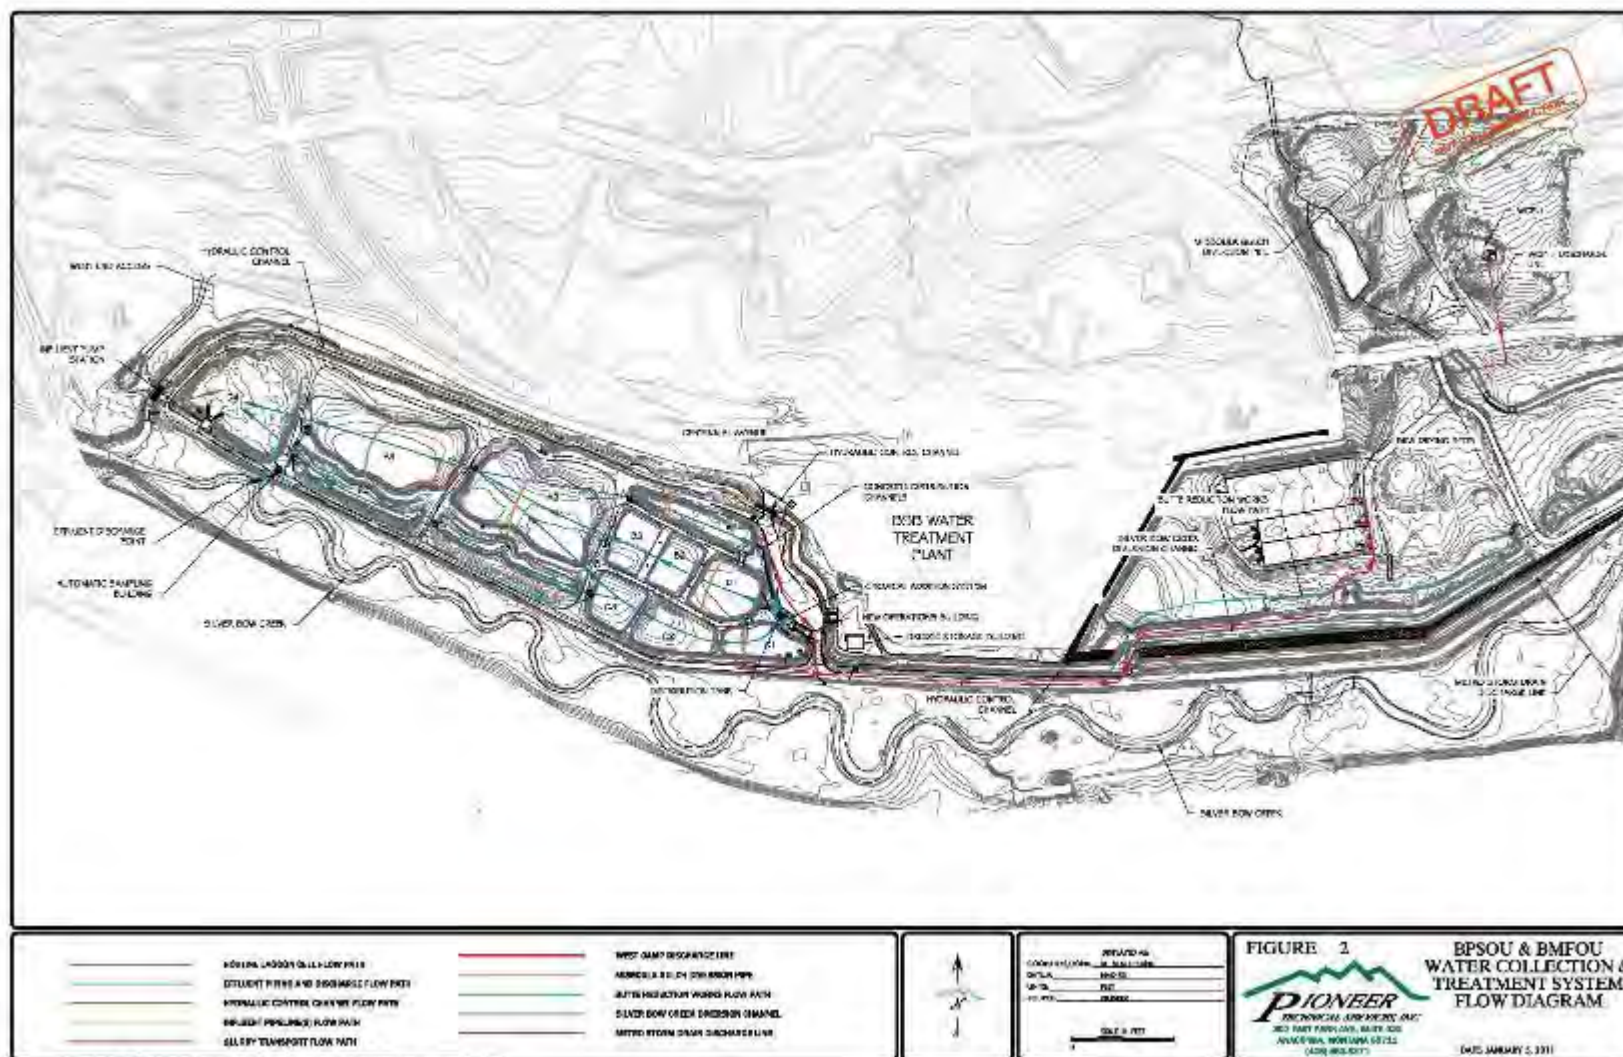
Figure H-2: BPSOU and BMFOU Water Collection Treatment System Flow Diagram

A fourth series of smaller, non-treatment cells, the D cells, is located south of lagoons A2 and A3. The D cells act as hydraulic barriers between the treatment cells and Silver Bow Creek. The A cells are separated by solid berms with manually adjustable stoplog weir overflow structures (identified as OS-1, OS-5 and OS-7), while the cells within the B and C systems are separated by cobble berms. Control structures are installed in positions to allow diversion of flows from cells B3 (OS-2) and C3 (OS-3) to the A cells, the effluent pipeline, or to the D cells, which allows for recirculation of the treated water. Typically, a third of the influent flow is directed into each A, B and C lagoon system. Waters exiting at B3 and C3 are combined, routed to the effluent pipeline to combine with treated water coming out of A3, or to cell A2 for additional treatment, and then discharged to Silver Bow Creek at CT-EFS7.
